SUBJECT: Draft Final Technical Project Planning (TPP) Memorandum for the Remedial Investigation/Feasibility Study (RI/FS) at the Lower Camp Debris Site, Defense Environmental Restoration Program for Formerly Used Defense Sites (DERP-FUDS) Property No. I02PR0068, Culebra, Puerto Rico

Technical Project Planning Meeting Memorandum

Remedial Investigation/Feasibility Study

Lower Camp Camp Debris Site – Project Number
I02PR006800

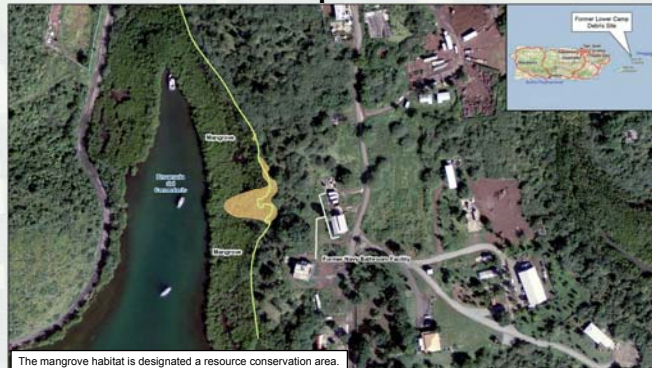
Lower Camp Debris Site

Edge of Mangrove Habitat

Estimated Extent of Debris Based on 2011 Site Inspection

Becky Terry/USACE clarified the 2011 Geophysical Survey (CH2M HILL, 2012) delineated the mangrove area boundary within the upland area. Cindy Martin/TRC Inc./PREQB Contractor requested that the septic tank be labeled on the figure. Bryan Burkingstock/CH2M concurred but noted the septic tank is outside the LCD area and that the investigation is focused only on the debris at the LCD site. The technical approach will have LCD site wells and background wells. Wilberto Cubero/USACE clarified that the USACE is not authorized to characterize sites used by non-DoD entities, so the USACE cannot investigate upgradient. Diane Wehner/NOAA NOS noted the importance of seeing how the upgradient site factors into the LCD site. Wilberto agreed that the USACE will use previous knowledge from the upgradient area as applicable and appropriate. Diane questioned that this investigation is driven by three sediment samples from E&E's 1996 Site Inspection report at the LCD site debris. Wilberto and Marianne Gruber/USACE answered "yes" but reiterated the USACE cannot investigate non-DoD use of a property. Eduardo Gonzalez/EPA expressed concern that the upland background samples may not be representative of the site.

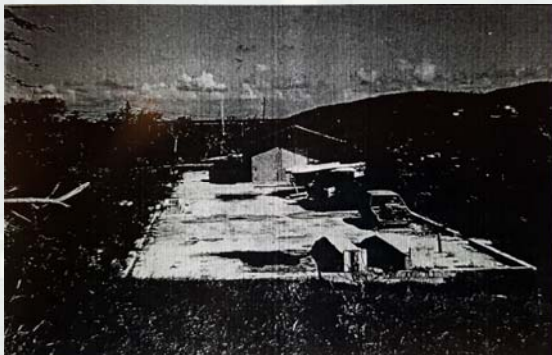
Former Navy bathroom facility pad being used by the Department of Conservation as an automotive shop. (Photo taken on July 19, 1996 [E&E])

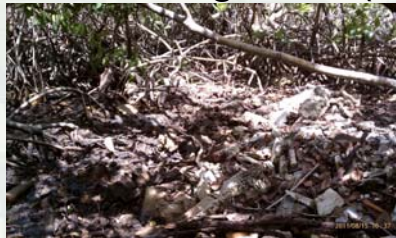
Lower Camp
Debris Site:
Visual Debris
(from CH2M HILL
2012 SI Report)

(Photo taken by
CH2M HILL
personnel on
August 15, 2011)

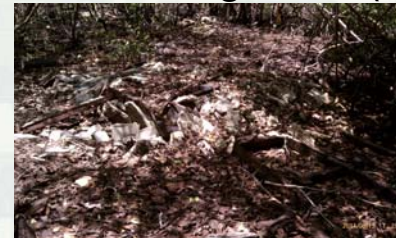
Lower Camp
Debris Site:
Visual Debris
(from CH2M HILL
2012 SI Report)

(Photo taken by
CH2M HILL
personnel on
August 15, 2011)

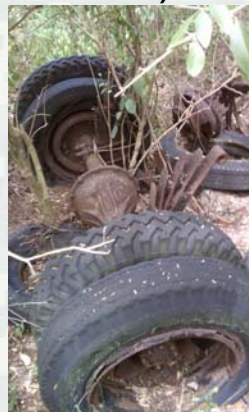
Lower Camp
Debris Site:
Visual Debris
(from CH2M HILL
2012 SI Report)

(Photo taken by
CH2M HILL
personnel on
August 15, 2011)

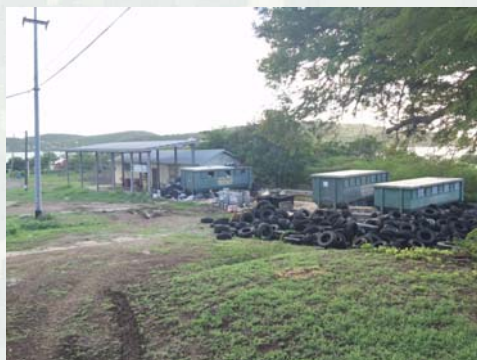
Former Navy
bathroom facility pad
being used as a
Vehicle Inspection
Center and a
recycling waste
collection facility.
(Photo taken by
USACE personnel on
November 5, 2015)

- Based on historical photographs, housing was arranged in a "tent city" format with the bathroom facility being one of the only permanent visible structures.
- The upland area upgradient of the LCD Site currently includes a concrete pad of the former Navy bathroom facility and the associated septic tank.
- The E&E 1996 Site Inspection Report indicated the concrete pad of the former Navy bathroom facility has been used by the Department of Conservation as an automotive shop subsequent to DoD property transfer.
- In addition, a recent LCD site visit conducted by USACE personnel revealed the concrete pad of the former Navy bathroom facility has been used as a Vehicle Inspection Center and is currently being used as a recycling waste collection facility.

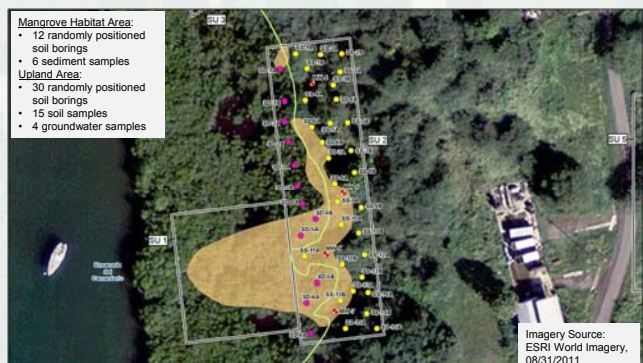
LCD Site - Sample Unit 2

- Proposed Monitoring Well
- Proposed Sediment Boring
- Proposed Soil Boring
- Edge of Mangrove Habitat
- Proposed Sample Unit
- Estimated Extent of Surface and Partially Buried Debris

Sampling Unit	Medium	Sample Depth (feet bgs)	Sampling Method	Number of Samples	Analytical Parameters
SU1	Sediment	0-0.5 foot (0.5-1 foot for VPH)	Composite (grab for VPH)	9	PAHs, PCBs, TAL metals, AVS/SEM Metals, VP/HEPH, TOC, and grain size
SU2	Sediment	0-0.5 foot (0.5-1 foot for VPH)	Composite (grab for VPH)	6	PAHs, PCBs, TAL metals, AVS/SEM Metals, VP/HEPH, TOC, and grain size
	Surface soil	0-1 foot unless crab habitat is identified, then 0-2 feet	Composite (grab for VPH)	15	PAHs, PCBs, TAL metals, and VP/HEPH
	Groundwater	Variable	Grab	4	PAHs, TAL metals (filtered/unfiltered), VP/HEPH, pH, chloride, TDS, and salinity

SU1 – Mangrove Habitat within Debris Area (LCD Site)
SU2 – Mangrove Habitat and Upland Area within Debris Area (LCD Site)

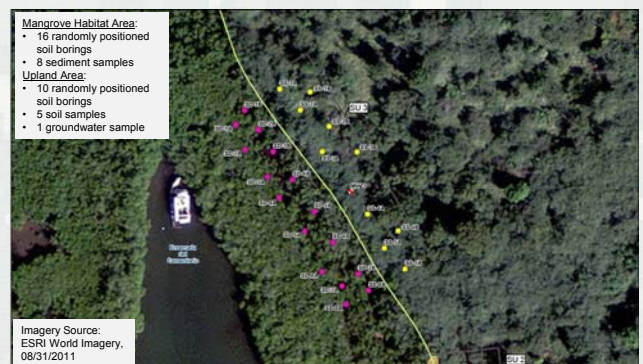
Background - Sample Unit 3

- Proposed Monitoring Well
- Proposed Sediment Boring
- Proposed Soil Boring
- Edge of Mangrove Habitat
- Proposed Sample Unit
- Estimated Extent of Surface and Partially Buried Debris

Sampling Unit	Medium	Sample Depth (feet bgs)	Sampling Method	Number of Samples	Analytical Parameters
SU3 (Figure 13)	Sediment	0-0.5 foot	Composite	8	PAHs, TAL metals, TOC, and grain size
	Surface soil	0-1 foot unless crab habitat is identified; then 0-2 feet	Composite	5	PAHs and TAL metals
	Groundwater	Variable	Grab	1	PAHs, TAL metals (filtered/unfiltered), pH, chloride, TDS, and salinity
SU4 (Figure 14)	Sediment	0-0.5 foot	Composite	7	PAHs, TAL metals, TOC, and grain size
	Surface soil	0-1 foot unless crab habitat is identified; then 0-2 feet	Composite	5	PAHs and TAL metals
	Groundwater	Variable	Grab	1	PAHs, TAL metals (filtered/unfiltered), pH, chloride, TDS, and salinity
SU5 (Figure 15)	Surface soil	0-1 foot unless crab habitat is identified; then 0-2 feet	Composite	5	PAHs and TAL metals
	Groundwater	Variable	Grab	2	PAHs, TAL metals (filtered/unfiltered), pH, chloride, TDS, and salinity

SU3, SU4, and SU5 – Background Sample Units Outside Debris Area

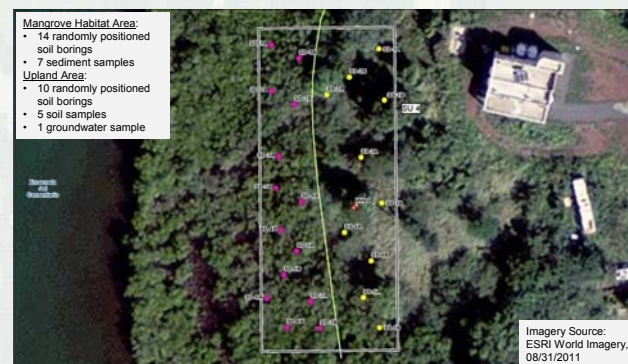
Background - Sample Unit 4

- Proposed Monitoring Well
- Proposed Sediment Boring
- Proposed Soil Boring
- Edge of Mangrove Habitat
- Proposed Sample Unit
